AVERAGE DAILY LABOUR FEB 2017: 320

TOWER-1 (TYPE A-1) (Overall completion 91.30 %)

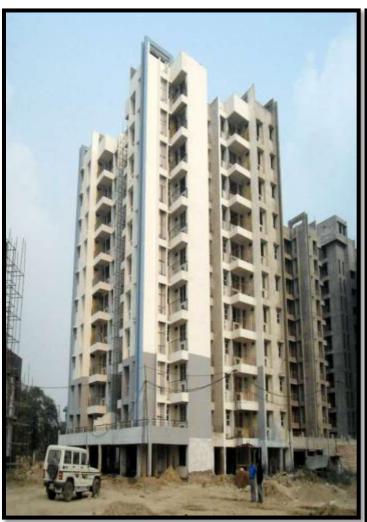
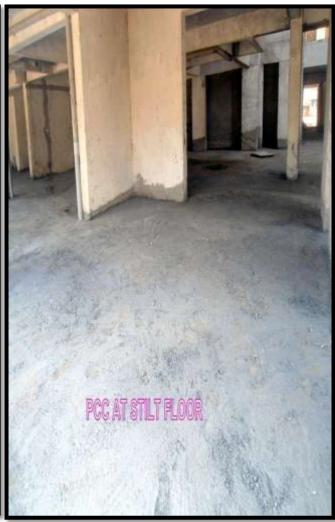
Progress – Anti termite & PCC at stilt floor and Glass fixing in Aluminum windows.

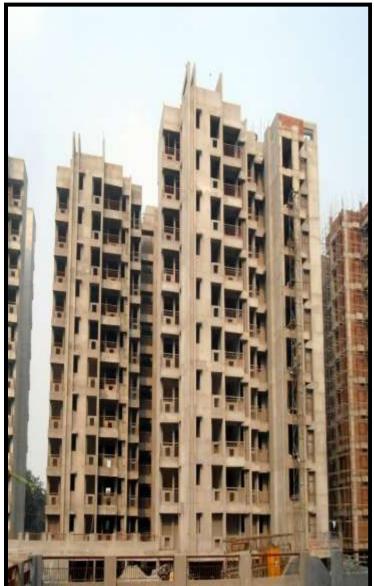
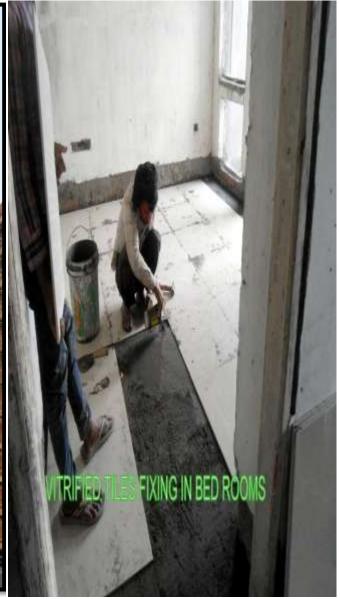
TILE FLOORING

Progress – Casting of top slab of OH water tank, Vitrified tiles fixing in bed rooms, water proofing of toilets, kitchens, balconies& lift pit, plumbing work in shafts & toilets.

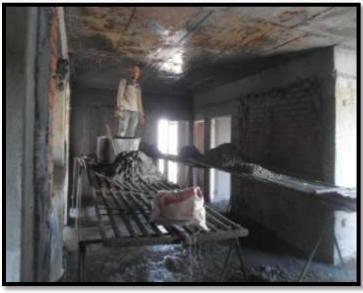
EXTERNAL PLASTER

Progress – External & Internal plaster, door frame fixing, brick work of parapet wall & plumbing shaft.

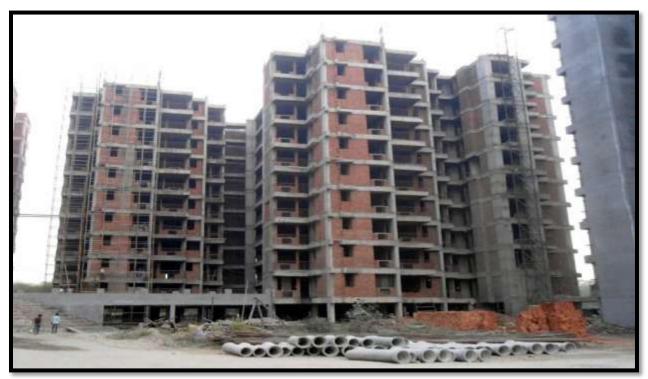
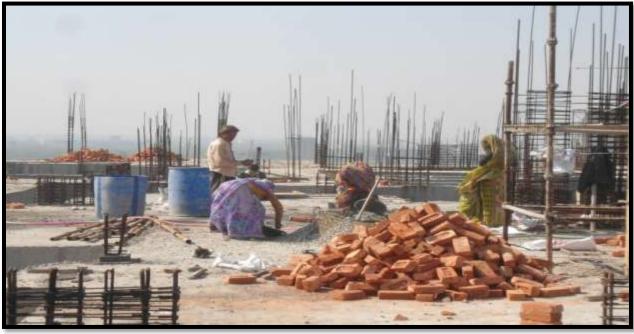
BRICK WORK IN TERRACE

Progress – Fixing of railing in balconies & brick work in front elevation and parapet.

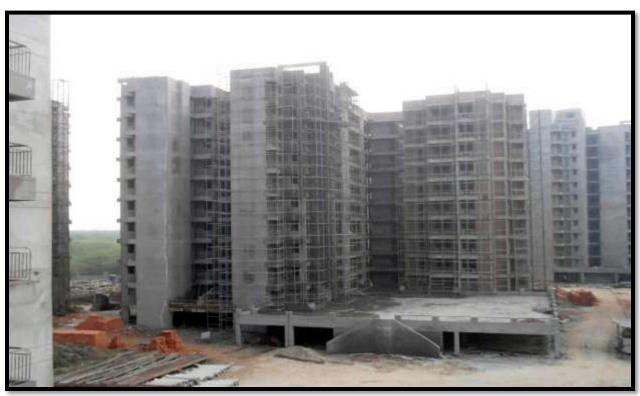
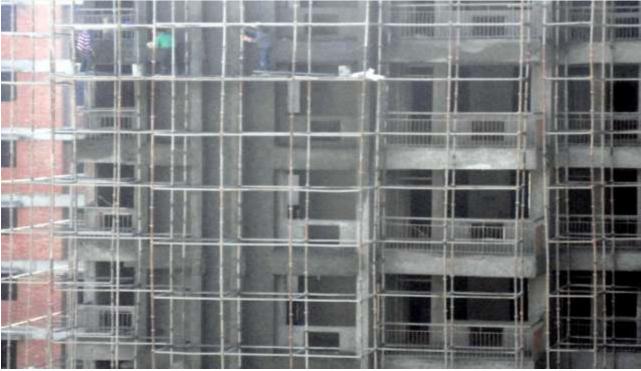
EXTERNAL PLASTERING

Progress – External plaster of flat 3, internal plaster at 10th floor, Casting of terrace floor column, shuttering of bottom slab of machine room & OH Water tank.

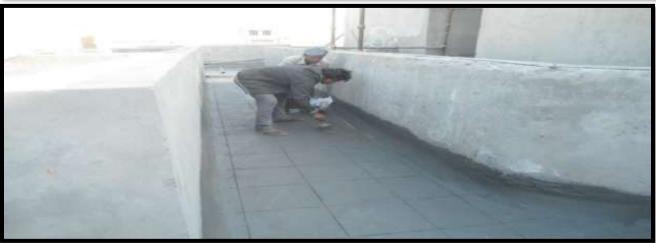
TILE FIXING INSIDE OH TANK

Progress –Fixing of Ceramic tiles in OH water tank, Terrace Koba & plaster repairing work.

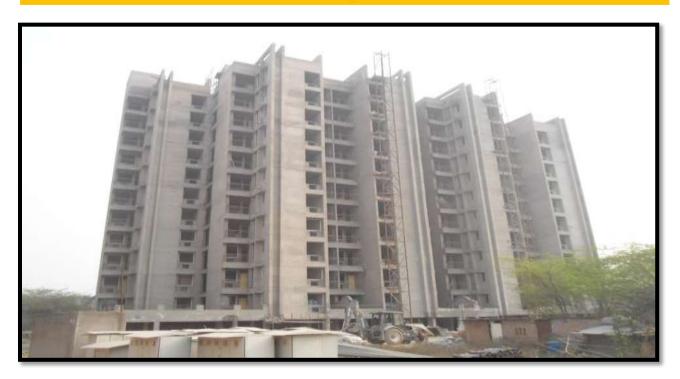
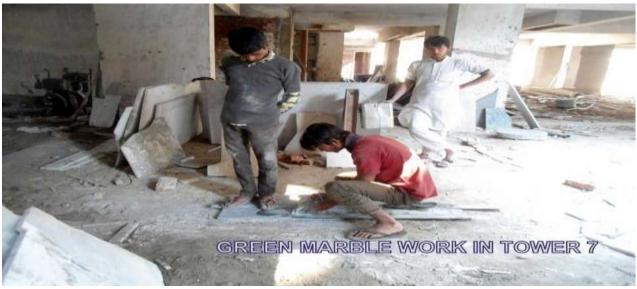
CORRIDOR & STAIR CASE GREEN MARBLE FIXING

Progress – External plaster in part-I, wall tiles fixing in toilets, Granite fixing on wash basin counters, Green marble fixing in staircase, Aluminum frame fixing in windows.

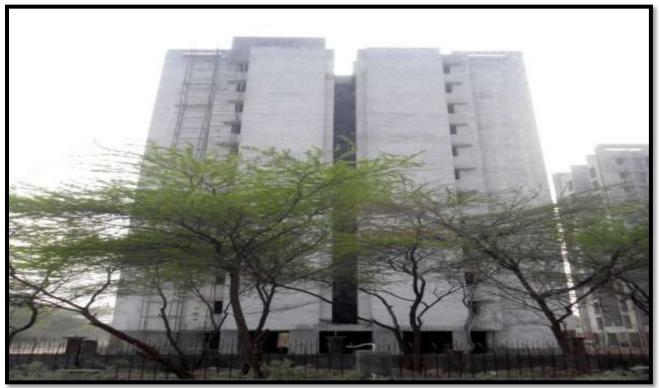
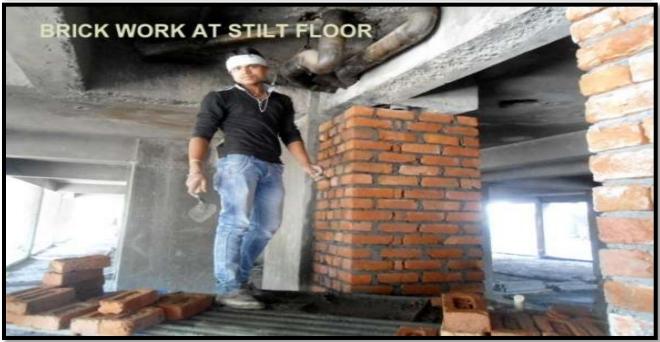
BRICK WORK STILT FLOOR PENDING WORKS

Progress – Brick work repairing at stilt floor, Glass fixing in Aluminium windows.

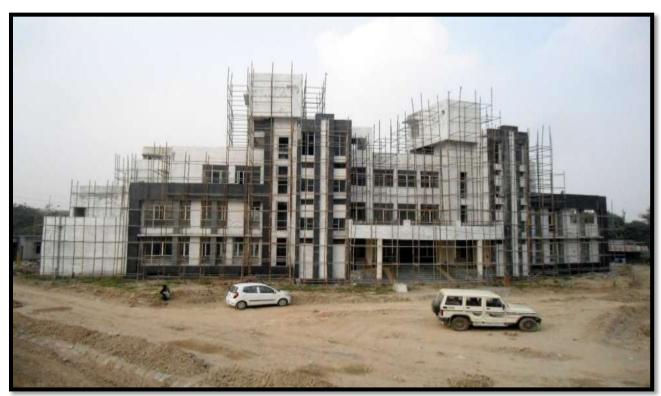
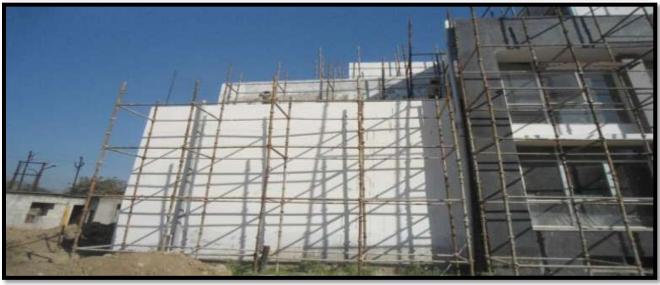
EXTERNAL PAINTING IN PROGRESS

COMMUNITY CENTRE - (Overall completion 90.00 %)
Total floor – Basement +03
Progress – External primer in progress.

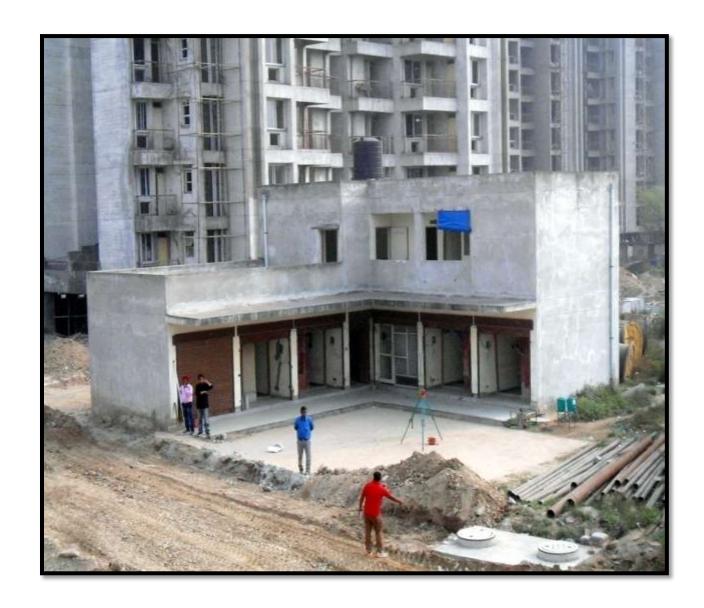
FACILITY BLOCK - (Overall completion 95.15 %) Total floor - Ground +01 Progress - No progress.

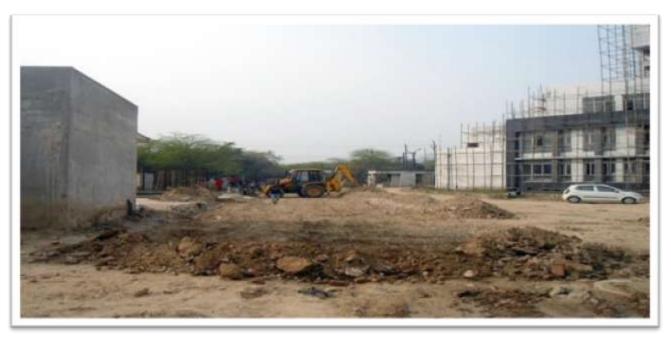
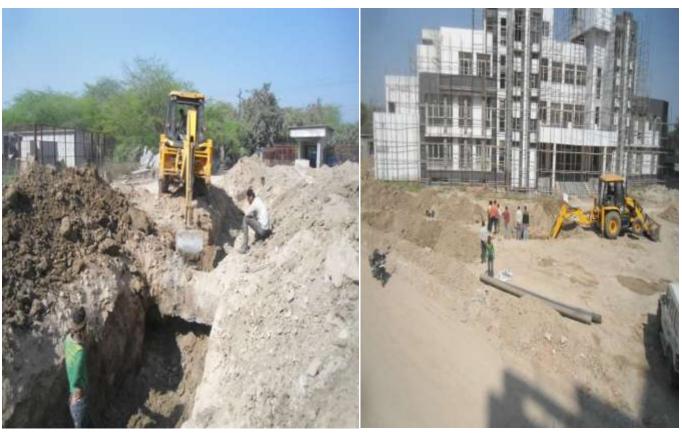
Gate No. 1 – (Overall Completion 90.00 %)
Progress- Road Work in Progress

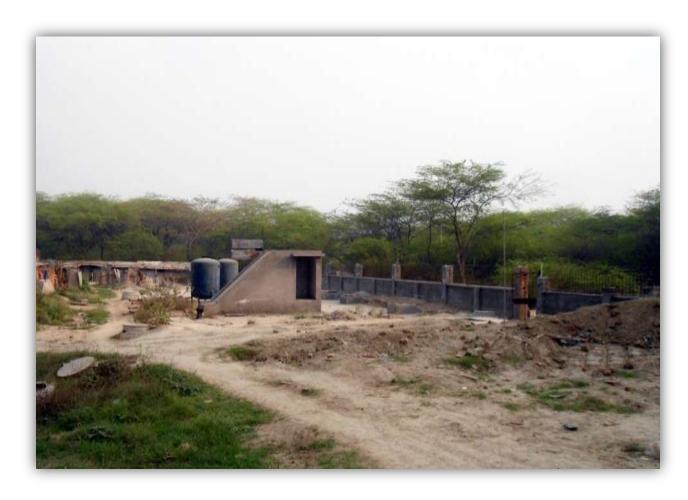
STP - (Overall Completion 37.26 %)
Progress- No Progress

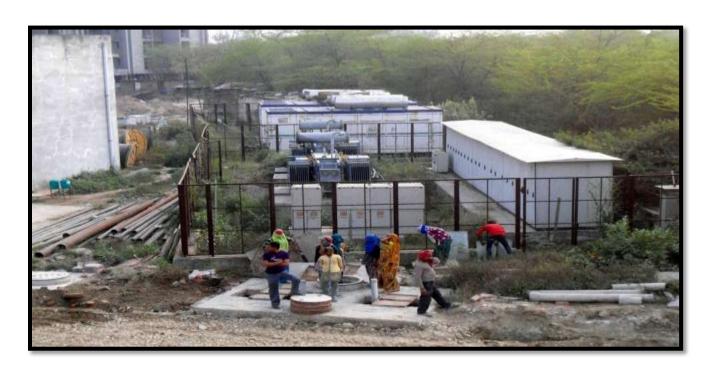
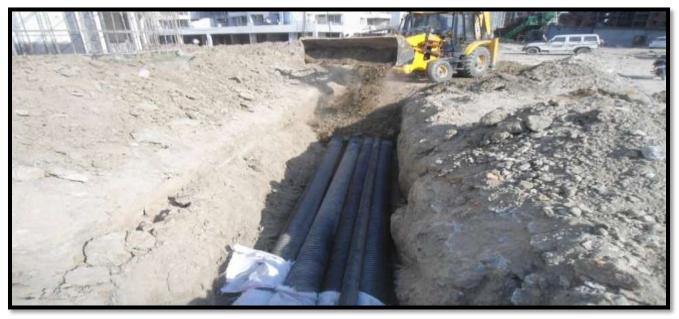
Power House - (Overall Completion 96.00 %)
Progress - Generators, Transformers, HT/LT cables and control Panels Procured,
Awaiting Energizing, Laying of cables in progress.
